CATHODIC PROTECTION/PARTIAL COATINGS

VERSUS

COMPLETE COATING in BALLAST TANKS-A PROJECT UPDATE

Prepared by  
Benjamin S. Fultz  
Associated Coating Consultants  
Galveston, Texas 77551  
in Cooperation with  
Avondale Shipyards, Inc.  
New Orleans, LA 70150

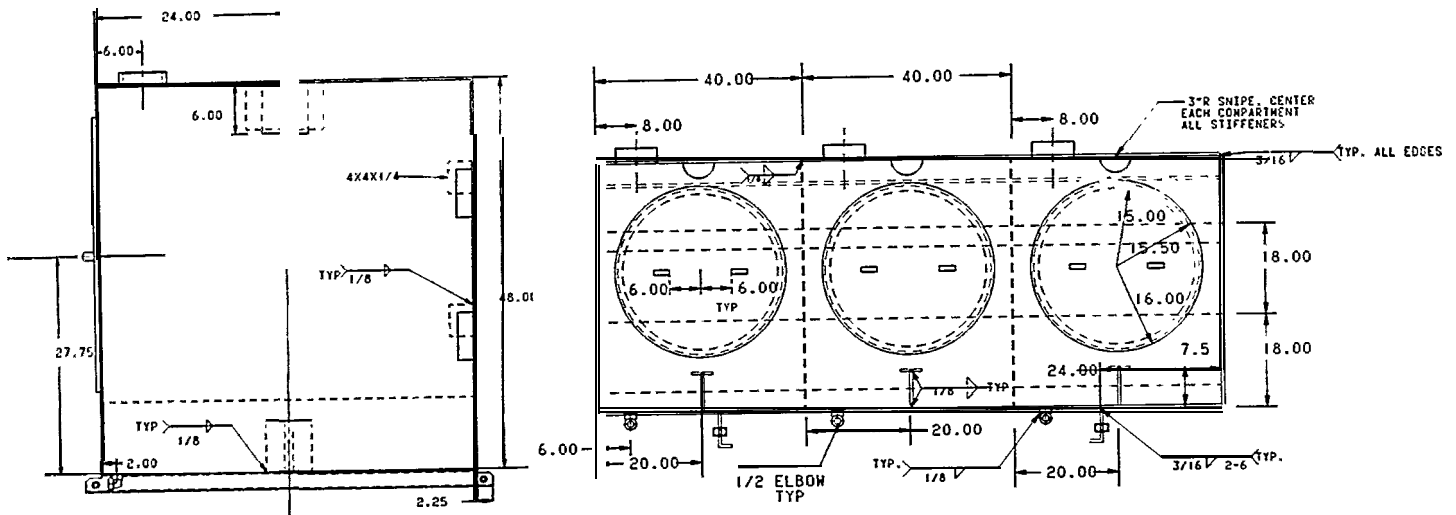
Figure 2.2: Drawing Showing Details of Test Tank Assembly

To verify the relative performance of each proposed alternate and the compatibilities between the cathodic protection and coating systems, three ballast tank assemblies (4' X 4' X 10') were fabricated from 1/4" A-36 steel plate and shapes. Each assembly consisted of three separate test tanks. (See Figure 2.1). Each tank was constructed to duplicate ship ballast tanks as concerns structure and configuration (See Figure 2.2). One side of each tank was of bolted construction to allow access for inspection.
